Dakota Gasification

Area Coated: Exterior Coating

Project Description:

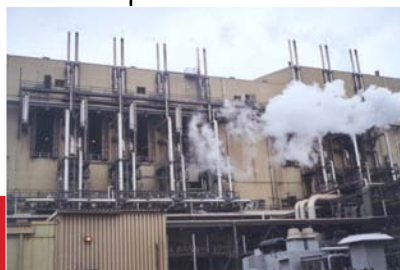
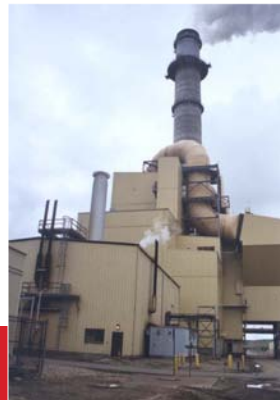
The pictures below were taken 10 year after the system was applied. The owner is overly impressed with how it has adhered and performed over the years.
